Assessment of Dam Safety of Coal Combustion Surface Impoundments

Indianapolis Power & Light Company

Eagle Valley Generating Station

Draft Report

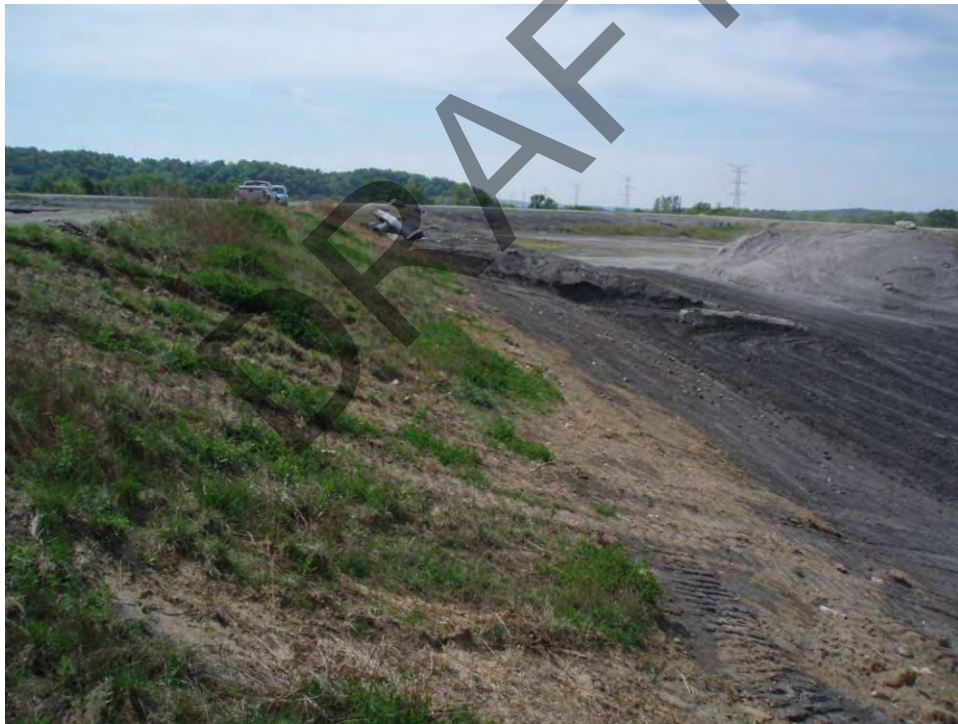
122. West slope of divider embankment D/E, looking south.

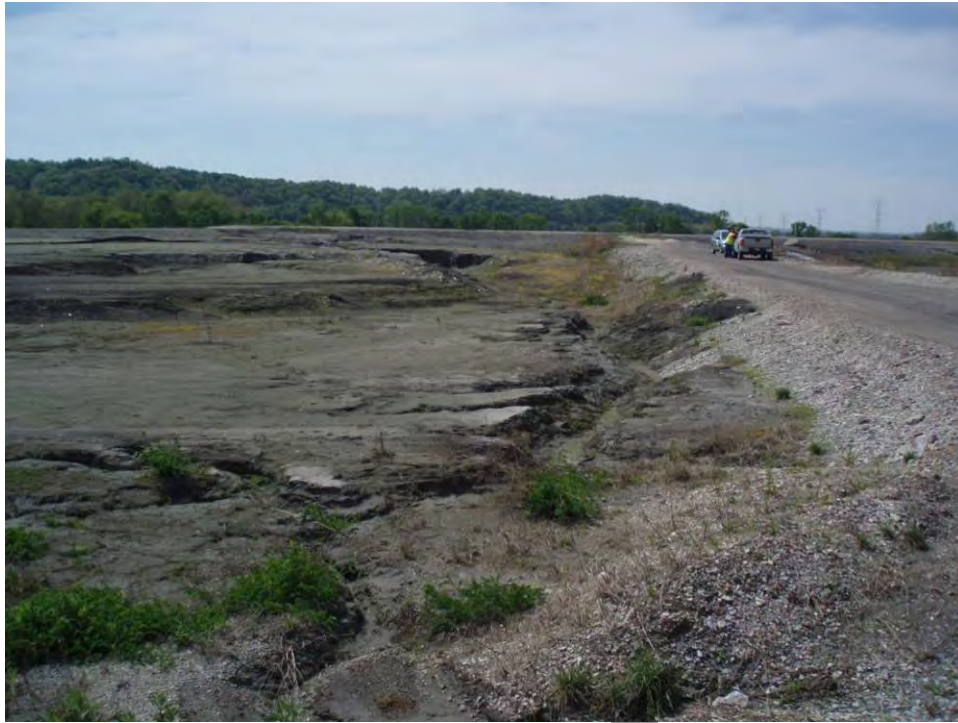
123. East slope of divider embankment D/E, looking south.

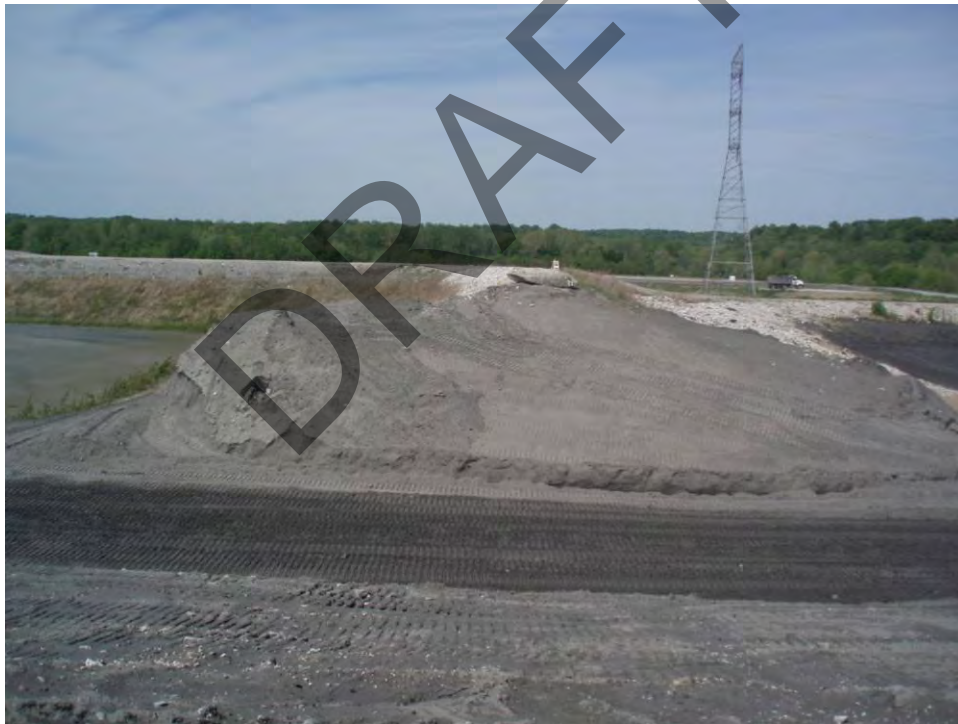
124. Overview of divider embankment D/E reconstruction, looking west.

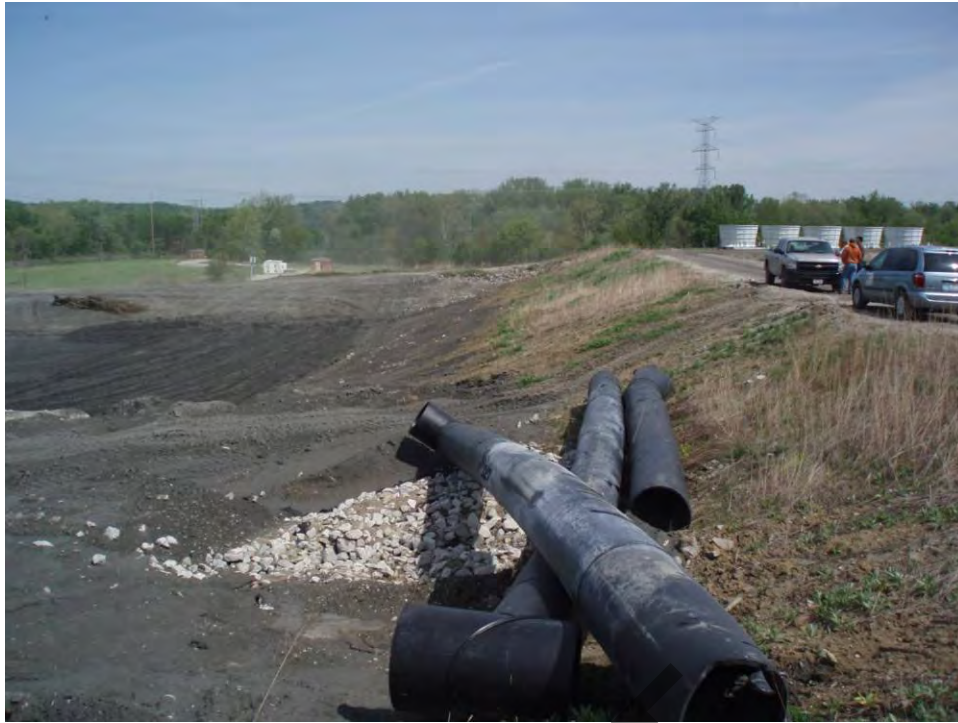
125. West slope of divider embankment D/E, looking north. Note pipes removed from embankment after breach.

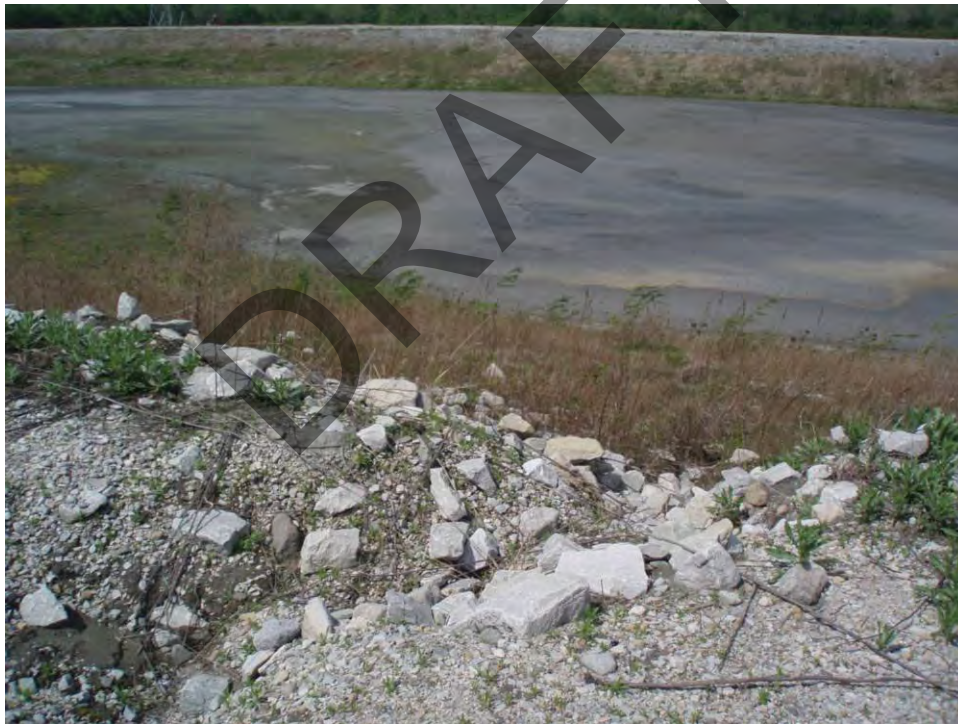
126. Pond D - Erosion rill on west slope of diversion embankment, looking southwest.

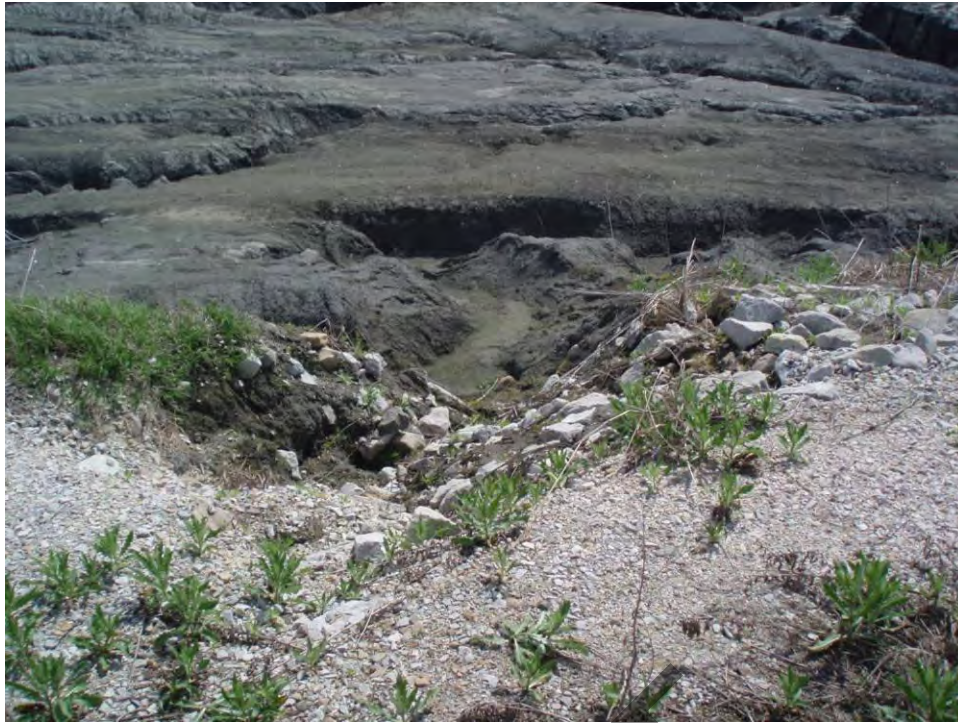
127. Pond D - Erosion feature on east slope of diversion embankment, looking east.

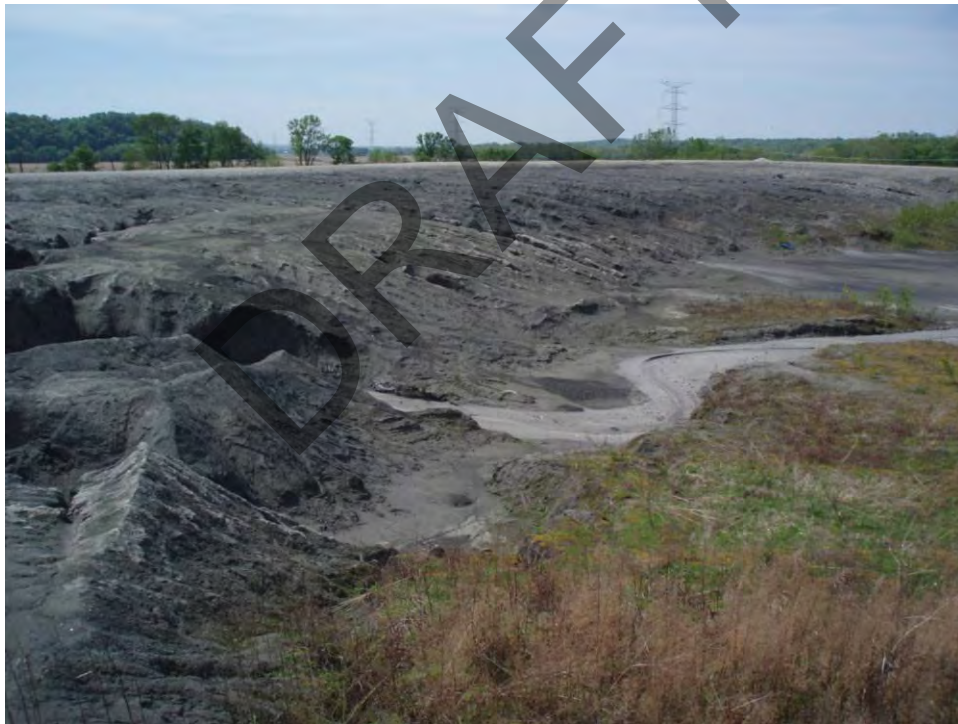
128. Pond D - Limit of ash at end of diversion embankment prior to failure, looking southwest.

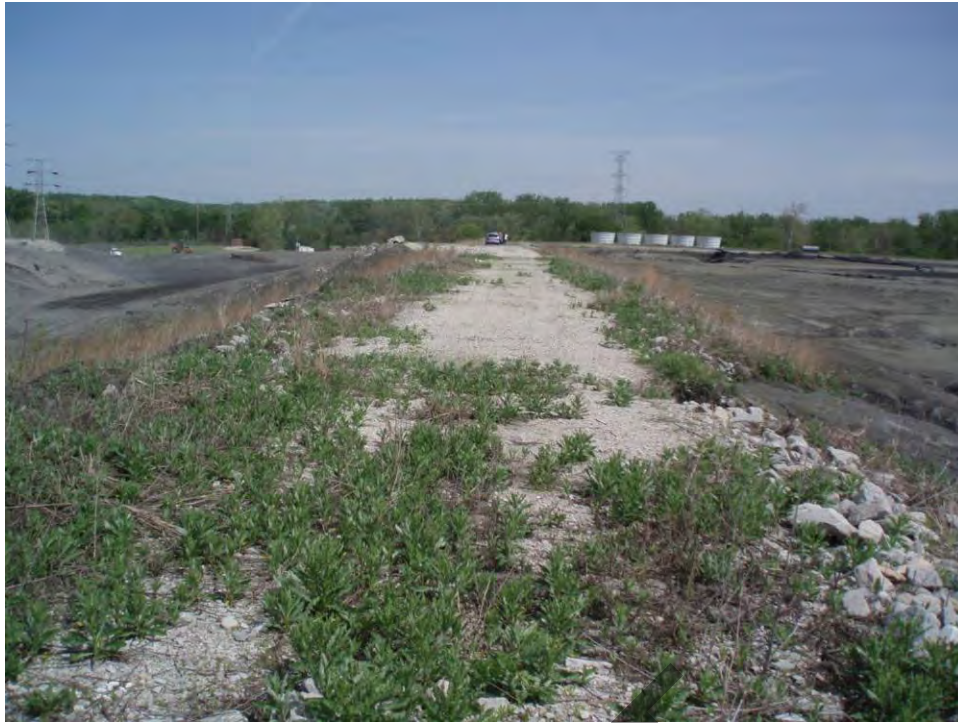
129. Pond D – Crest of diversion embankment, looking north.

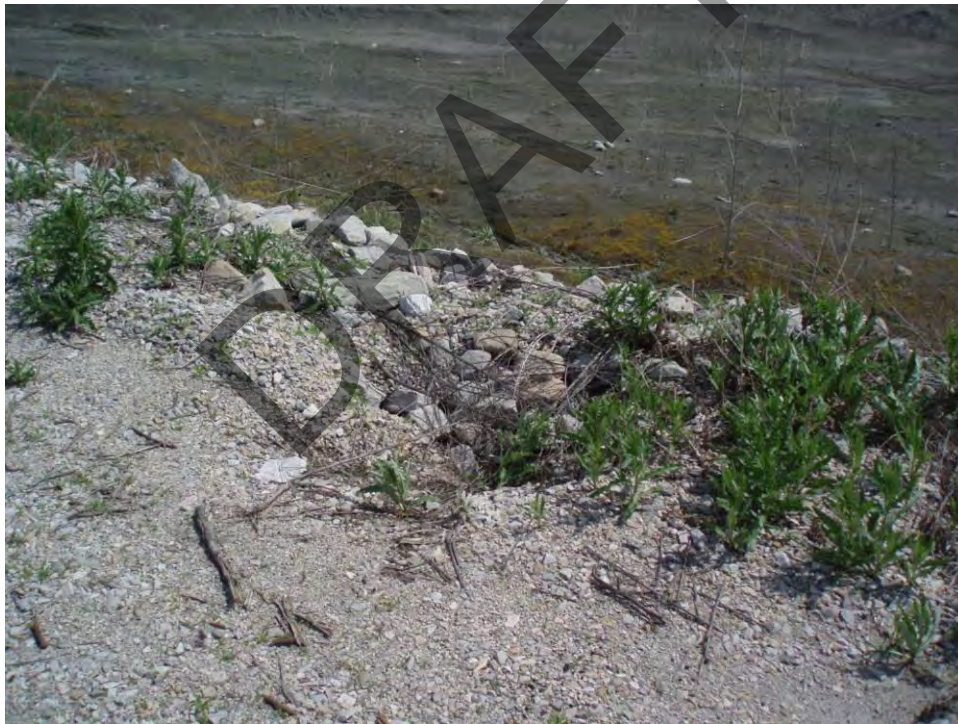
130. Pond D – Depression with piping on east slope of diversion embankment, looking northeast.

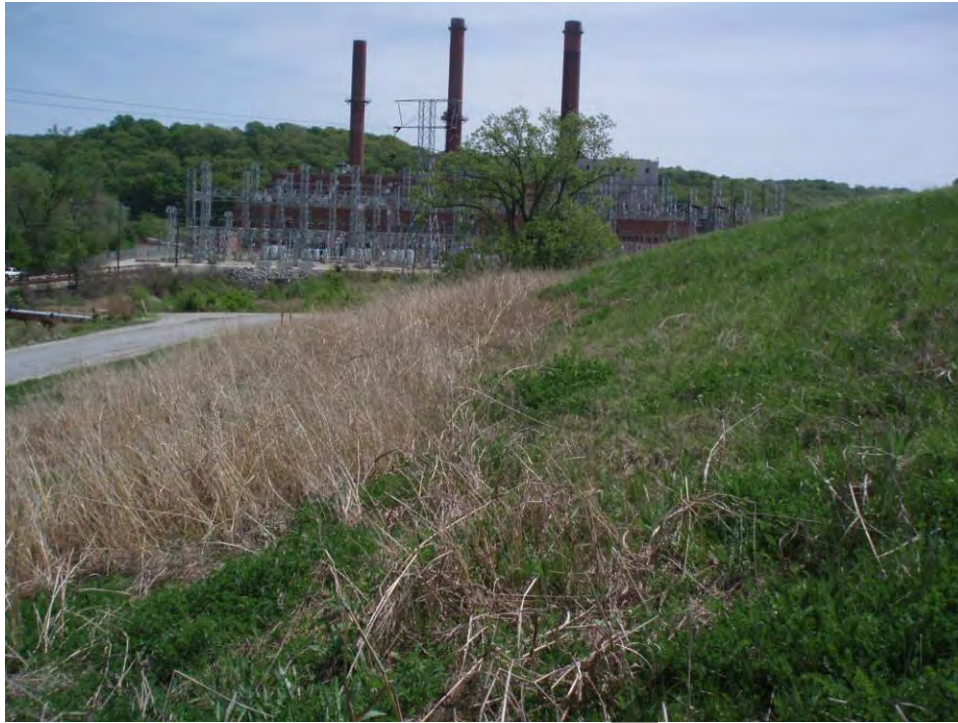
131. Pond D - North embankment exterior slope, looking east.

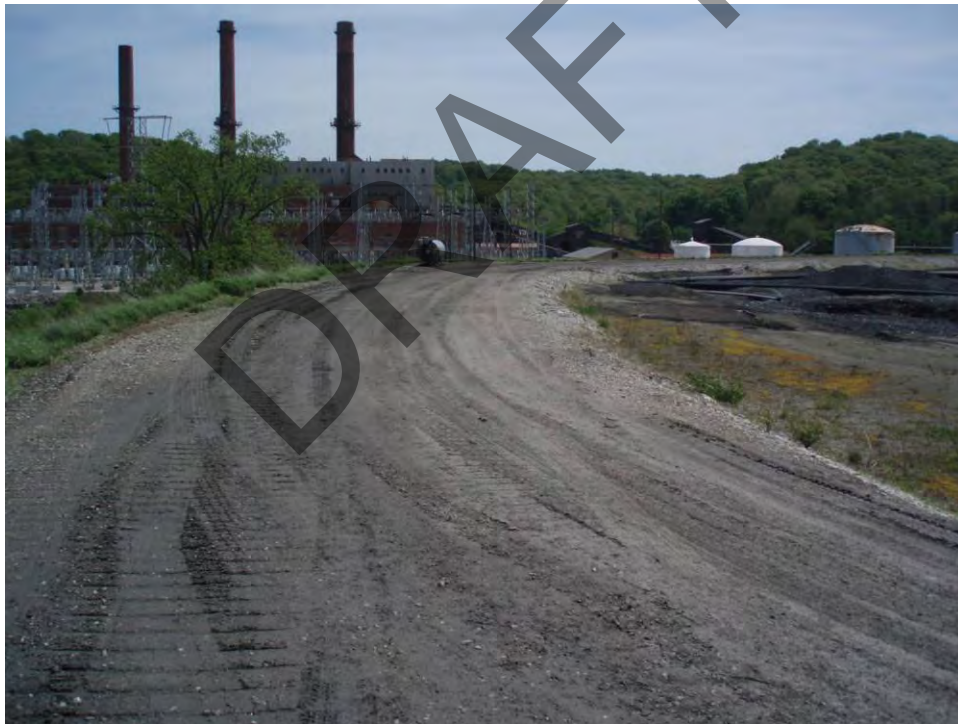
132. Pond D - North embankment crest, looking east.

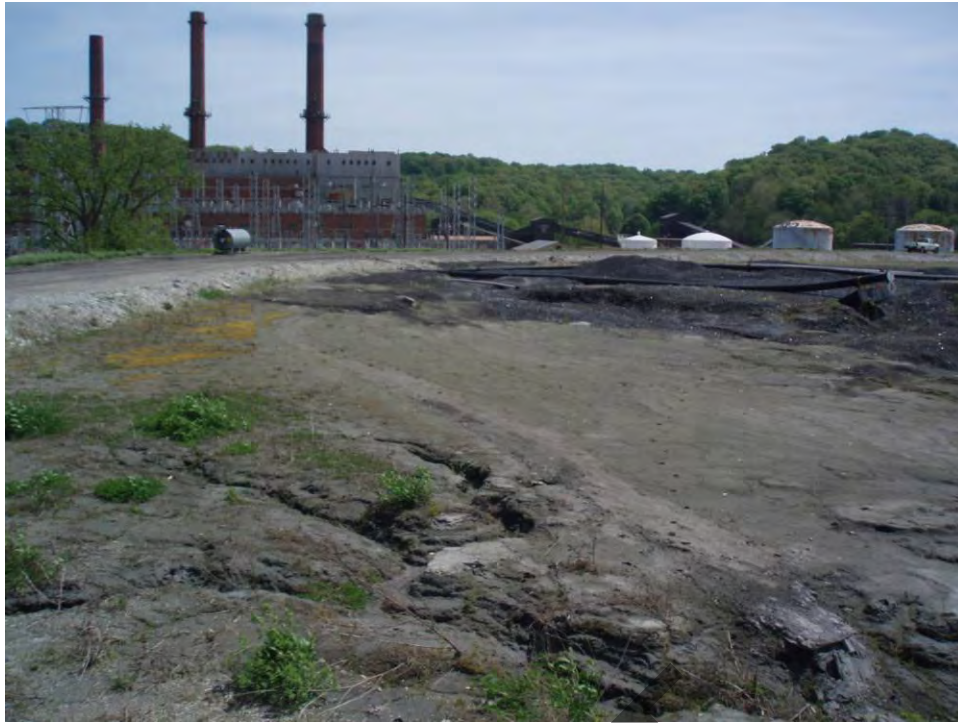
133. Pond D - North embankment interior slope, looking east.

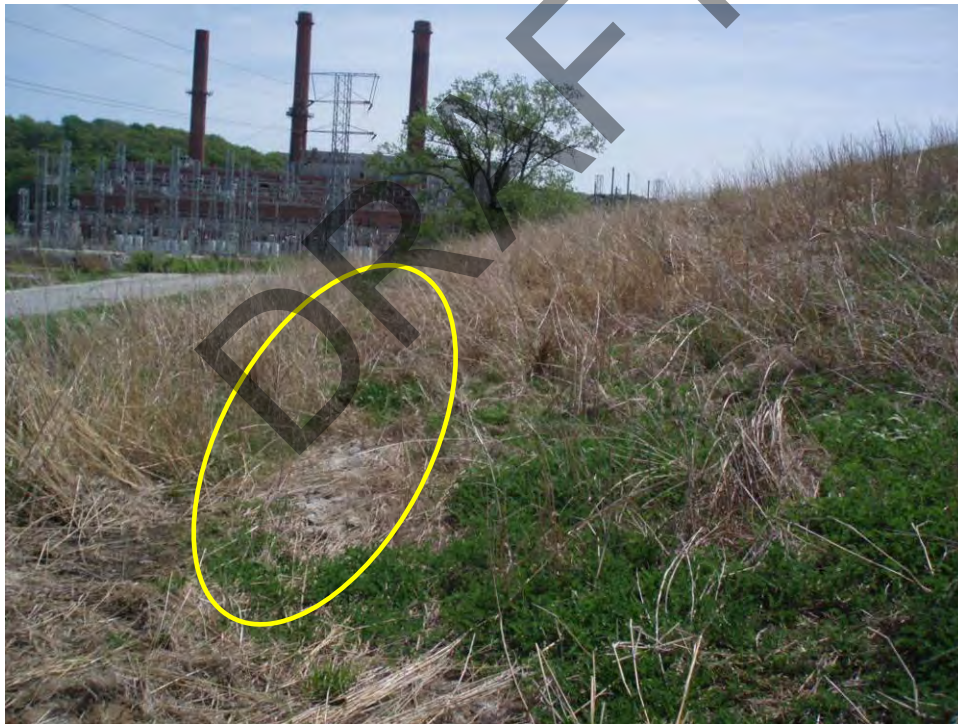
134. Pond D - Toe of north embankment, looking east. Note drainage ditch with seepage collector pipe.

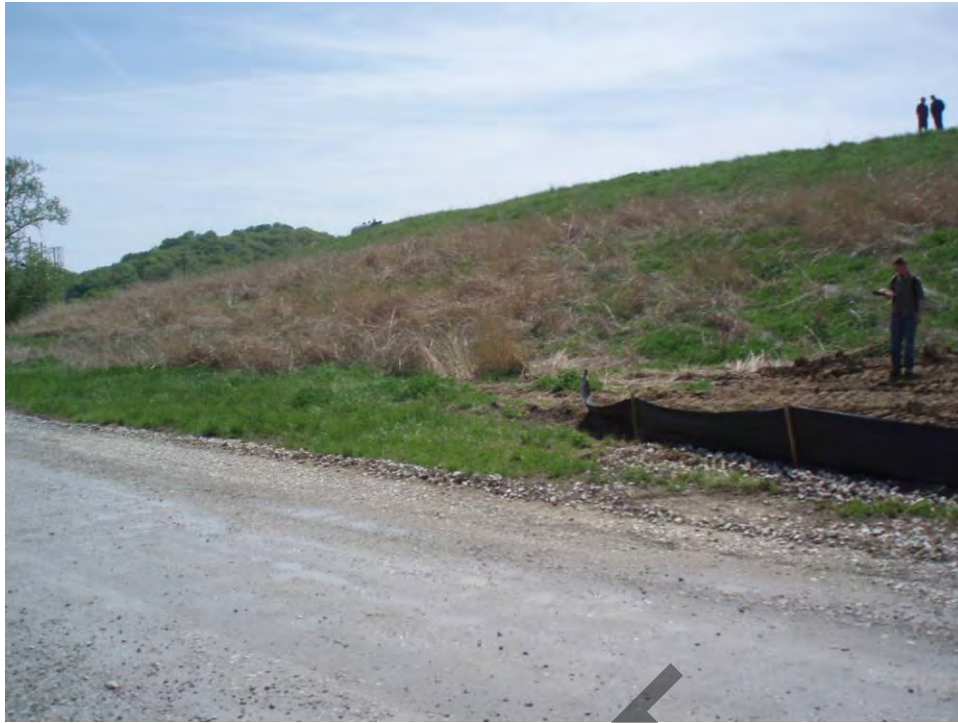
135. Pond D – North embankment exterior slope, looking southeast.

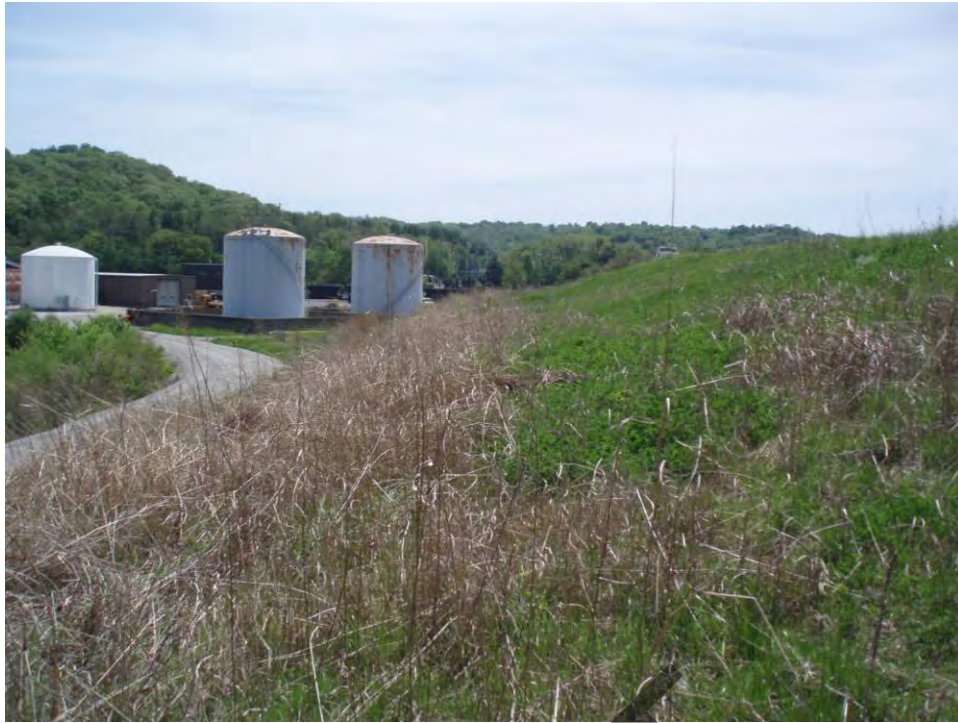
137. Pond D - Northeast embankment exterior slope, looking southeast.

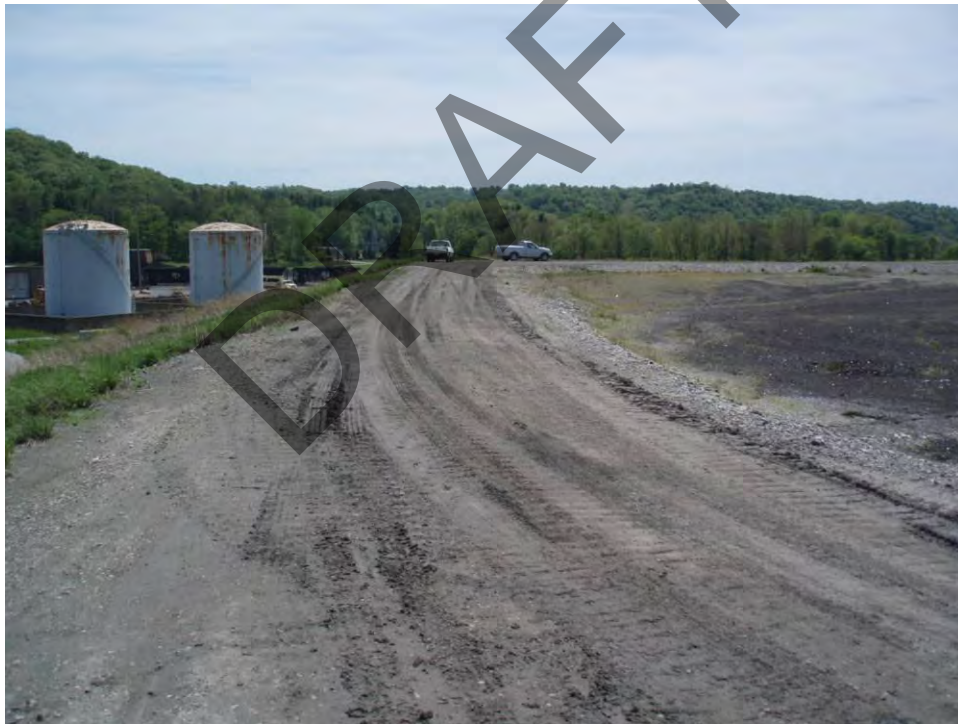
138. Pond D - Northeast embankment crest, looking southeast.

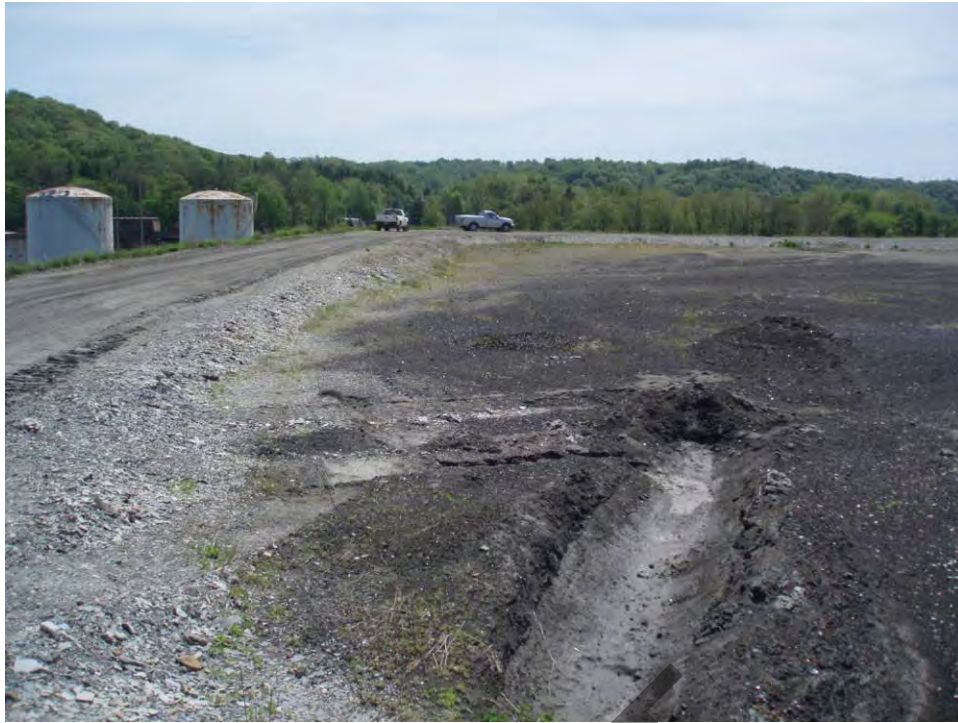
139. Pond D – Northeast embankment interior slope, looking southeast.

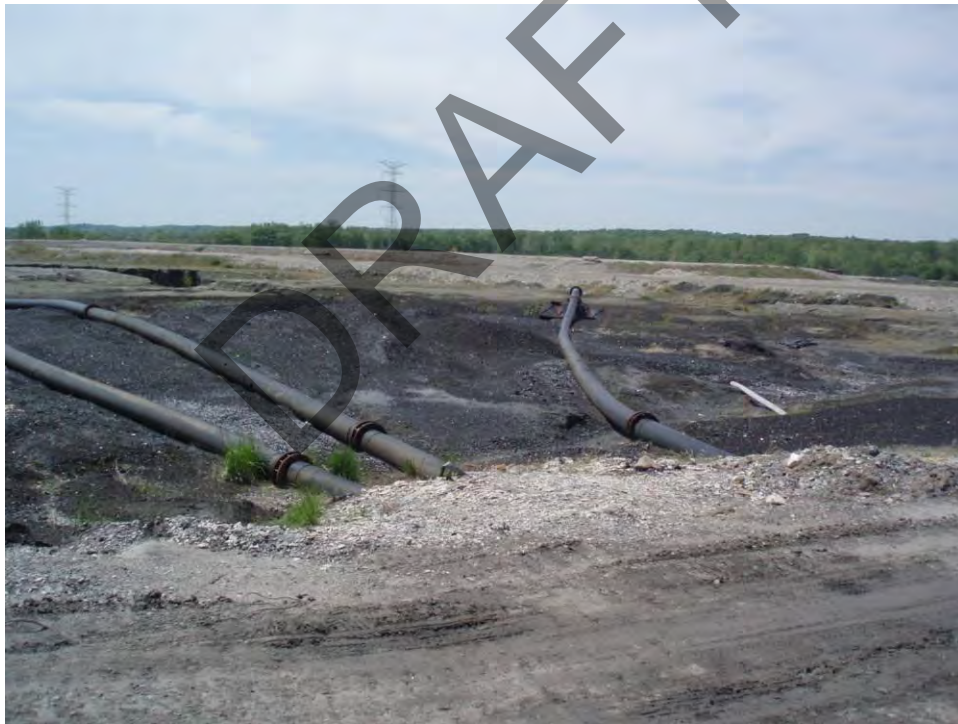
140. Overview of three 10-inch-diameter HDPE discharge pipes into Pond D, looking southwest.

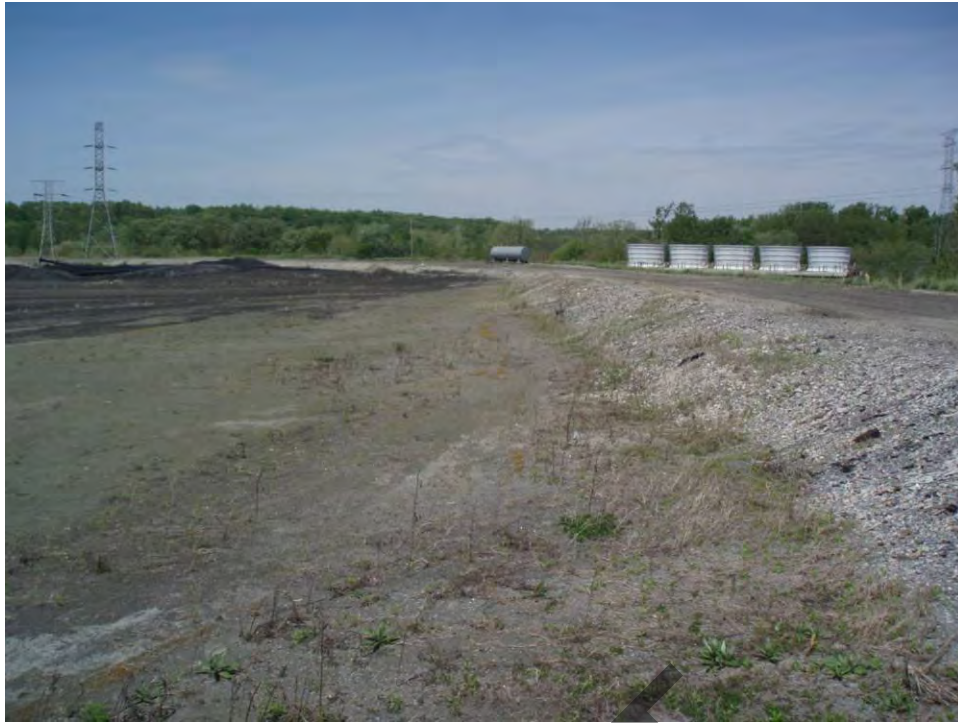
141. Pond D - Northeast embankment interior slope, looking northwest.

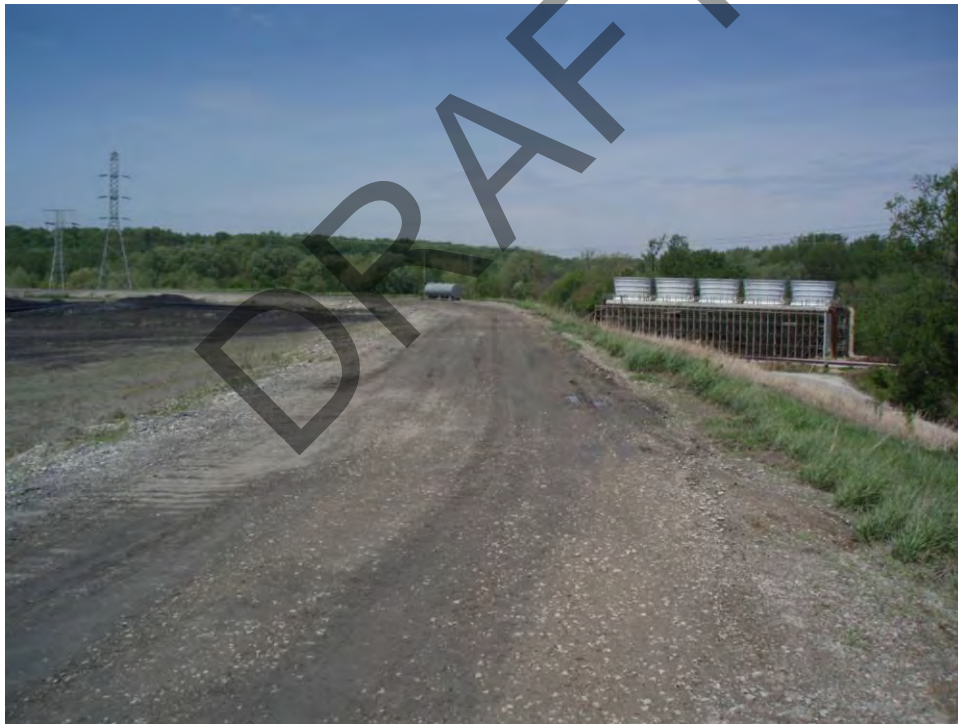
142. Pond D - Northeast embankment crest, looking northwest.

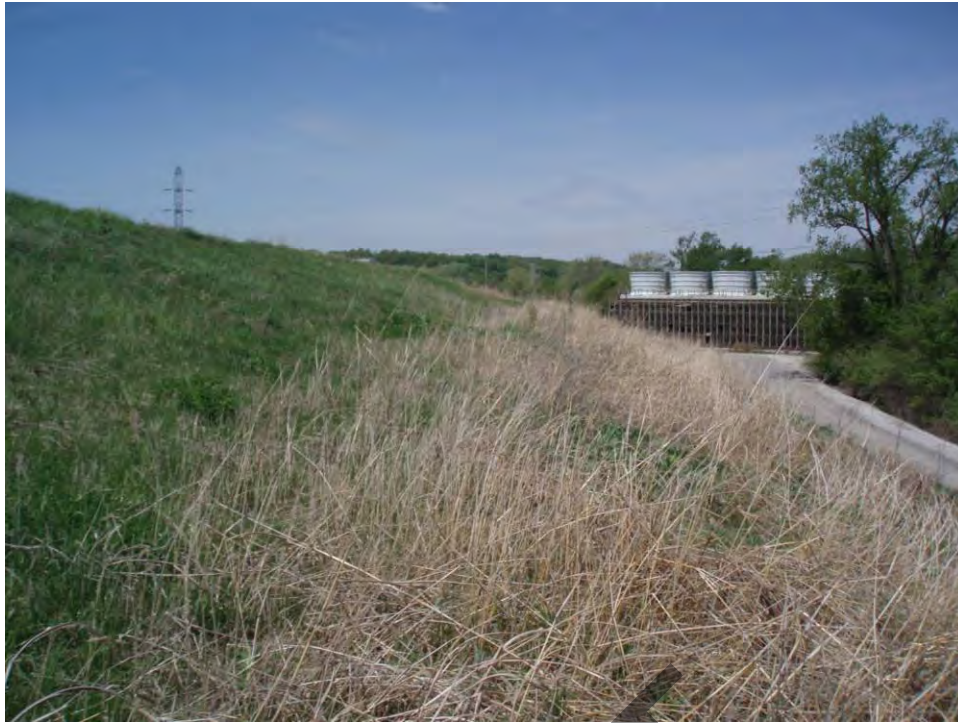
143. Pond D - Northeast embankment exterior slope, looking northwest.

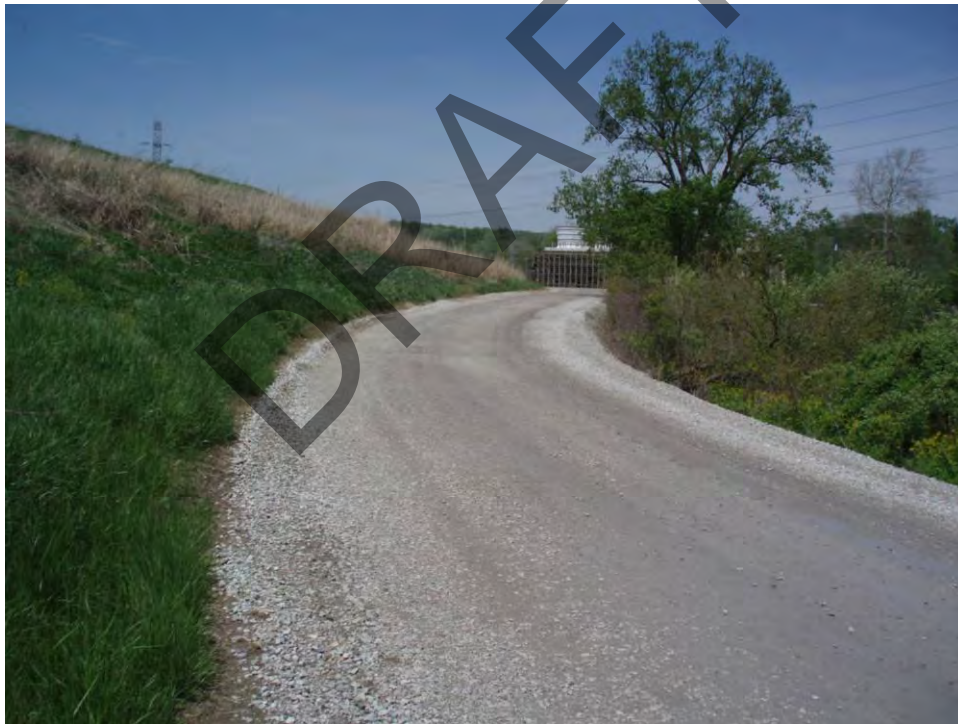
144. Access road and discharge canal adjacent to toe of Pond D, looking northwest.

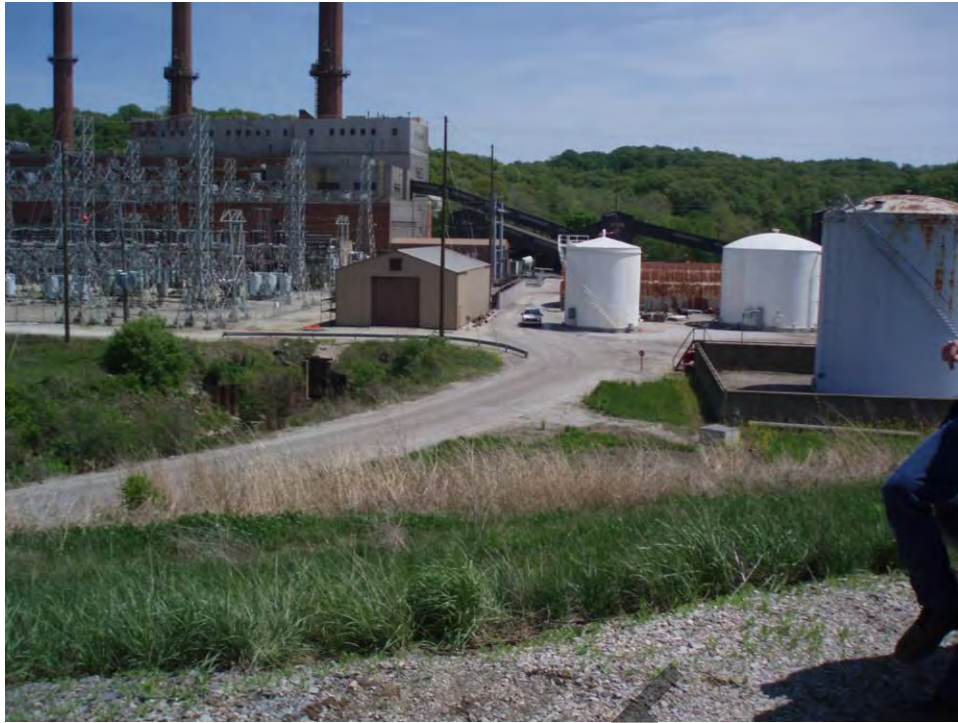
145. Downstream area of Pond D northeast embankment, looking east.

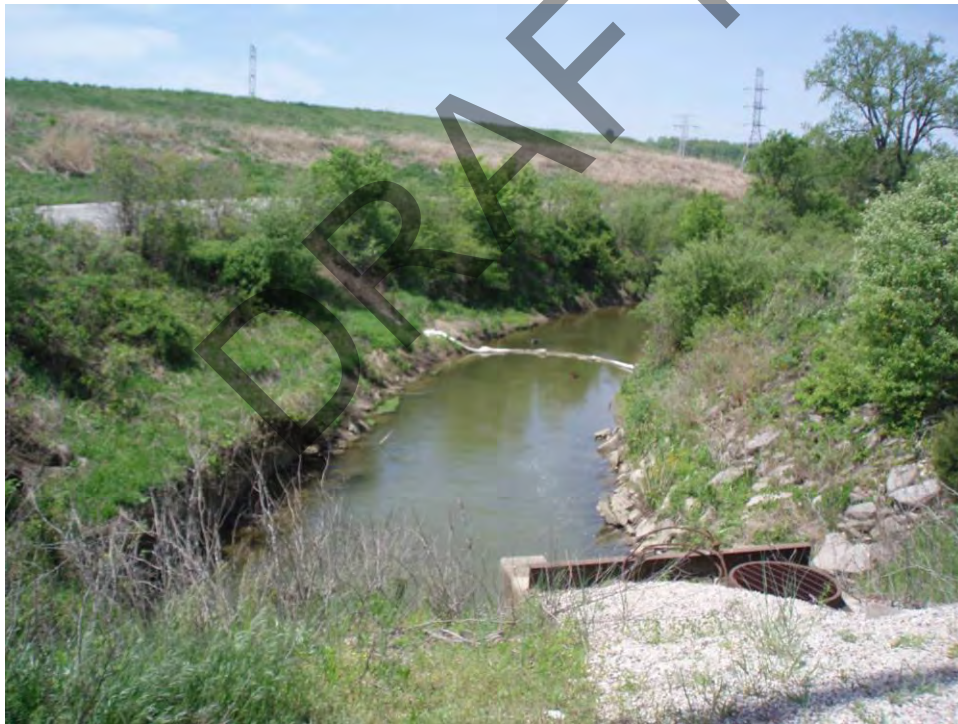
146. Overview of typical discharge canal adjacent the north embankments of Ponds A, C, D, and E.
